A13-OLinuXino-WIFI-DEV
step-by-step VGA hardware fix

This document applies ONLY to the very first batch of A13-OLinuXino-WIFI-DEV boards, which were sold with a problem in the VGA output with shipping costs covered by OLIMEX. As written on our page prior to selling the boards:

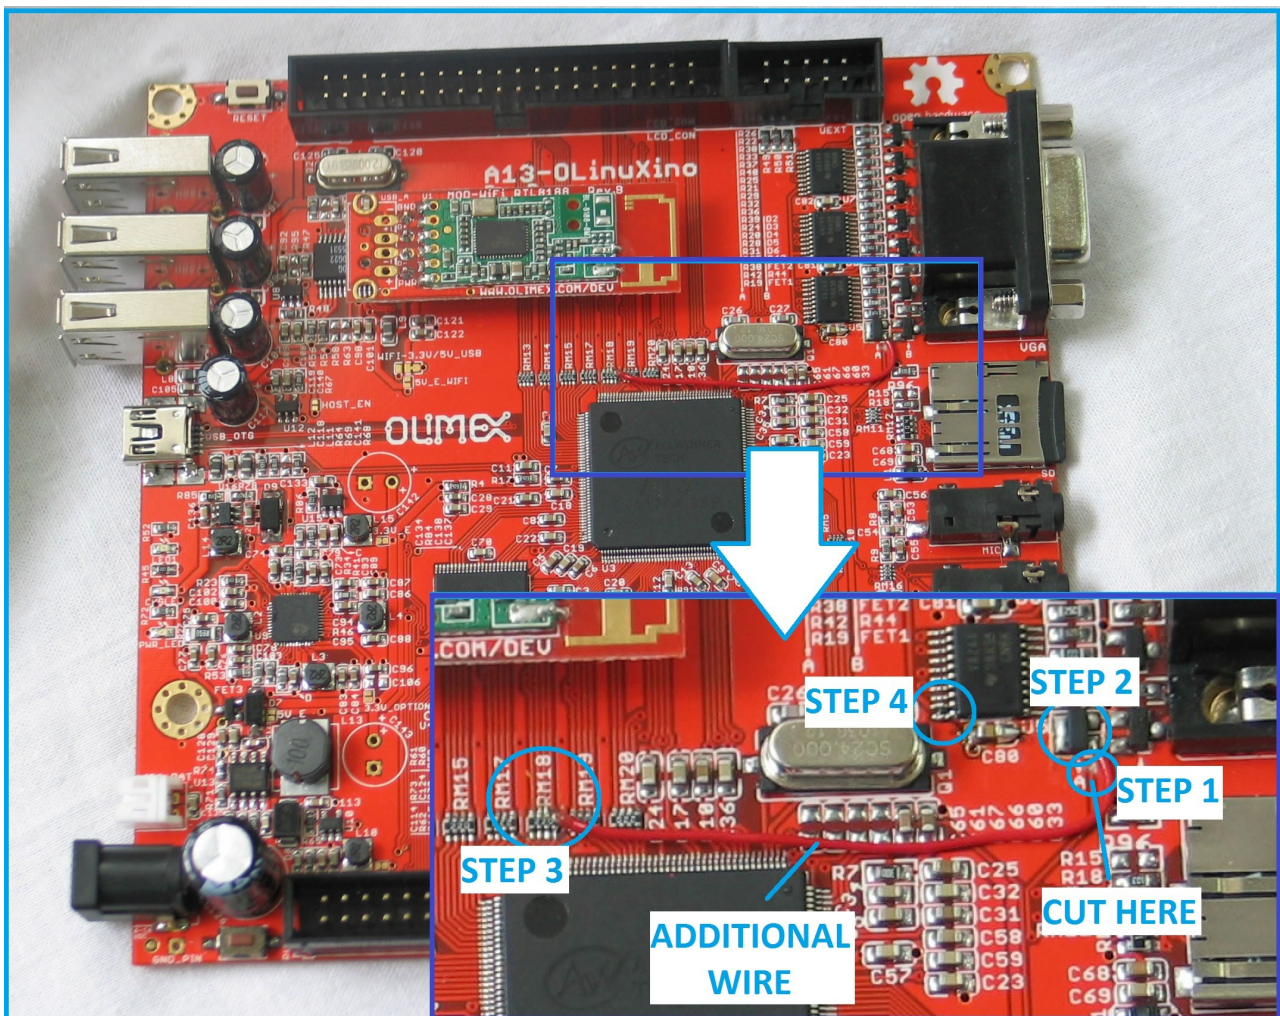
THIS BOARD IS NOW IN REV-B (DEVELOPER EDITION DEDICATED FOR EARLY DEVELOPERS ONLY) THE SOFTWARE SUPPORT IS NOT PERFECT ESPECIALLY VGA VIDEO.

Following the picture (the picture shows the fix applied) below we need to do 4 steps:

STEP 1 – Cut carefully the wire under R19 (which is not mounted) using a sharp knife or a proper tool. **IMPORTANT: if you don't disconnect the wire the workaround will not work.**

STEP 2 – 1. Unsolder R42 (over R19 pads);

2. On the now clear pads of R19 and R42 we solder the transistor mentioned in requirements – BSS138 or any NMOS transistor in SOT-23 package – its gate should be on the R19 right pad (check the picture how the transistor is situated);

3. Solder one end of the wire to the gate of the transistor

STEP 3 – Solder the other end of the wire to the 4th resistor of resistor matrix RM18 (RM18G4 on the schematics)

STEP 4 – Solder a 1k Ohms resistor between pin19 and pin20 of the U5.

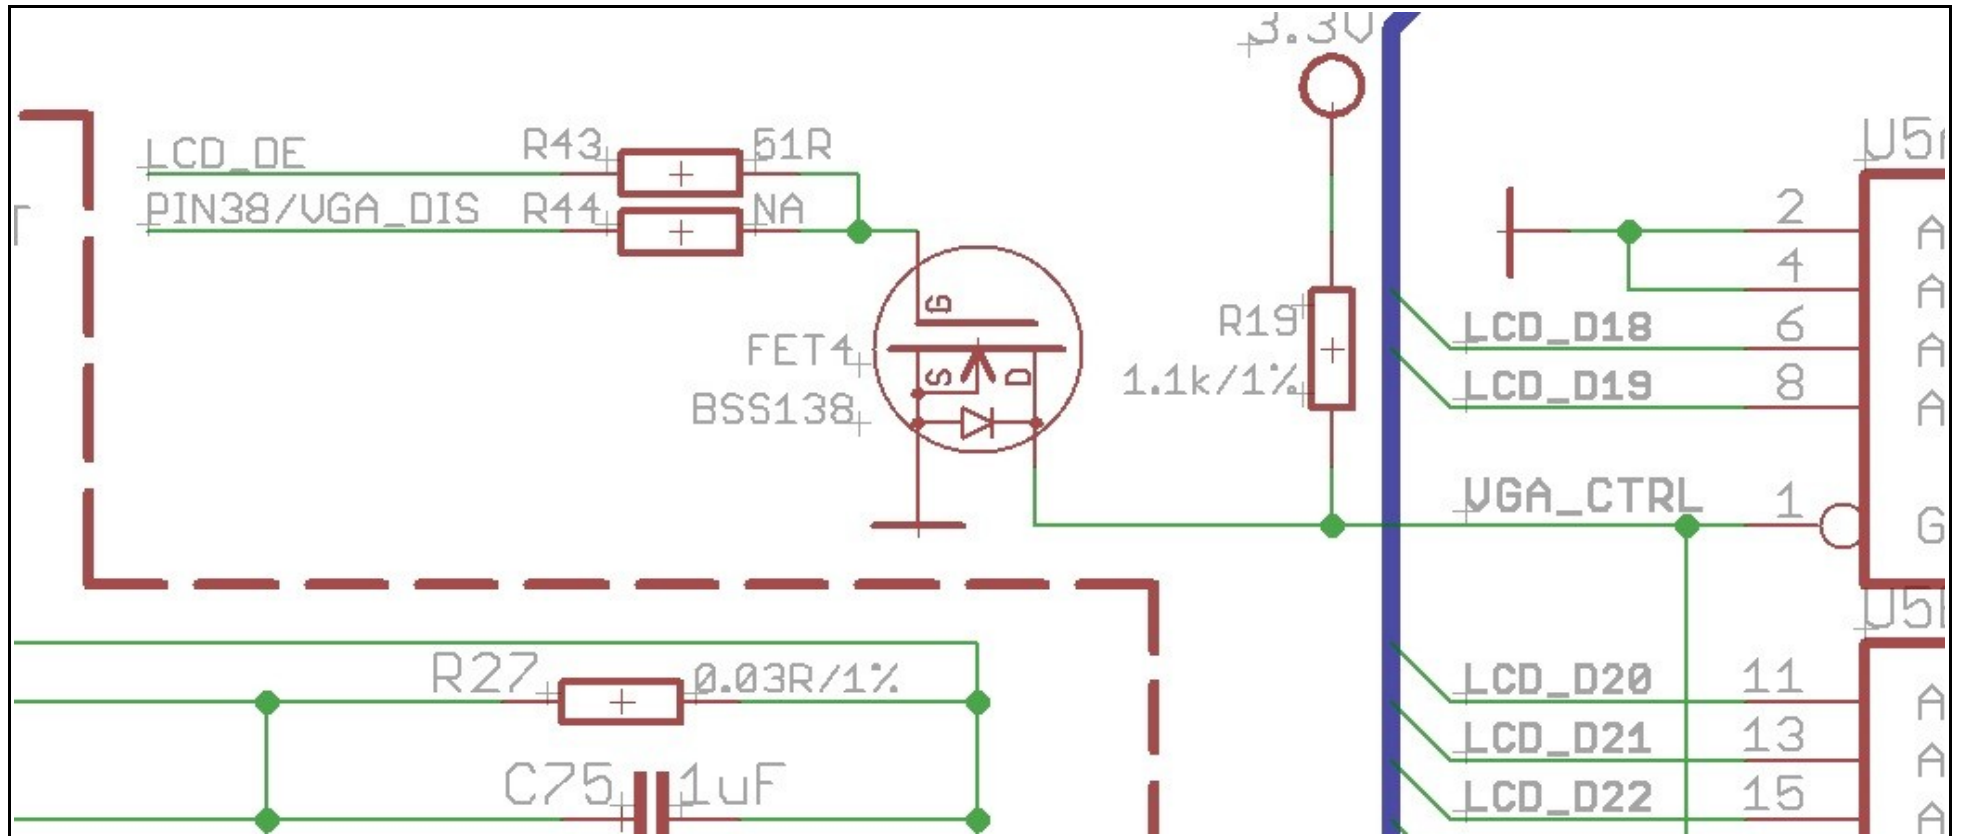
You can find how the changed part looks on the schematics:
