## PIC16F684 Rev. A Silicon/Data Sheet Errata

The PIC16F684 parts you have received conform functionally to the Device Data Sheet (DS41202D), except for the anomalies described below.

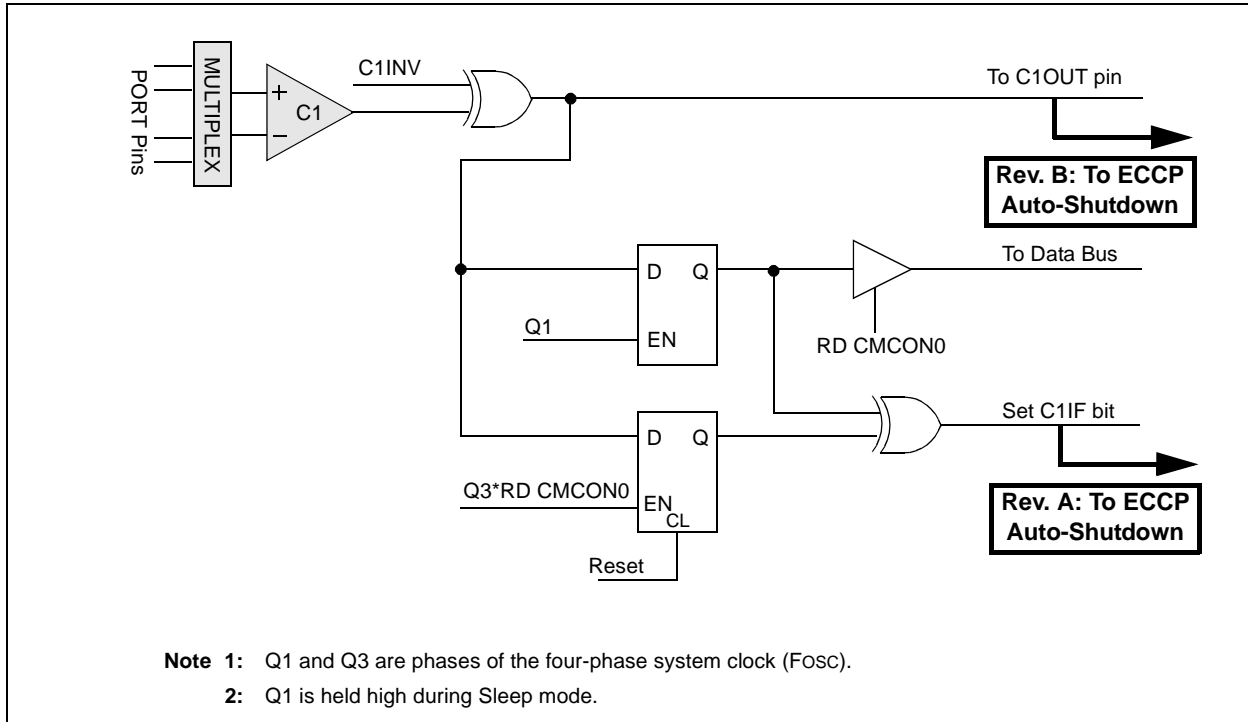
**FIGURE 8-2: COMPARATOR C1 OUTPUT BLOCK DIAGRAM**

The PIC16F684 Rev. A4 silicon for the ECCP Auto-Shutdown is connected to the C1IF and C2IF flags. See Figures 8-2 and 8-3 on the following page.

Rev. A4's auto-shutdown connection to C1IF and C2IF causes the auto-shutdown to incorrectly operate synchronously. Additionally, reads of CMCON0 will incorrectly clear an auto-shutdown event.

- 1) Poll the CxOUT bit until it is low.
- 2) Read CMCON1 to precondition CxIF.
- 3) If CMCON0 is read while CxOUT is changing, repeat steps 1 and 2.

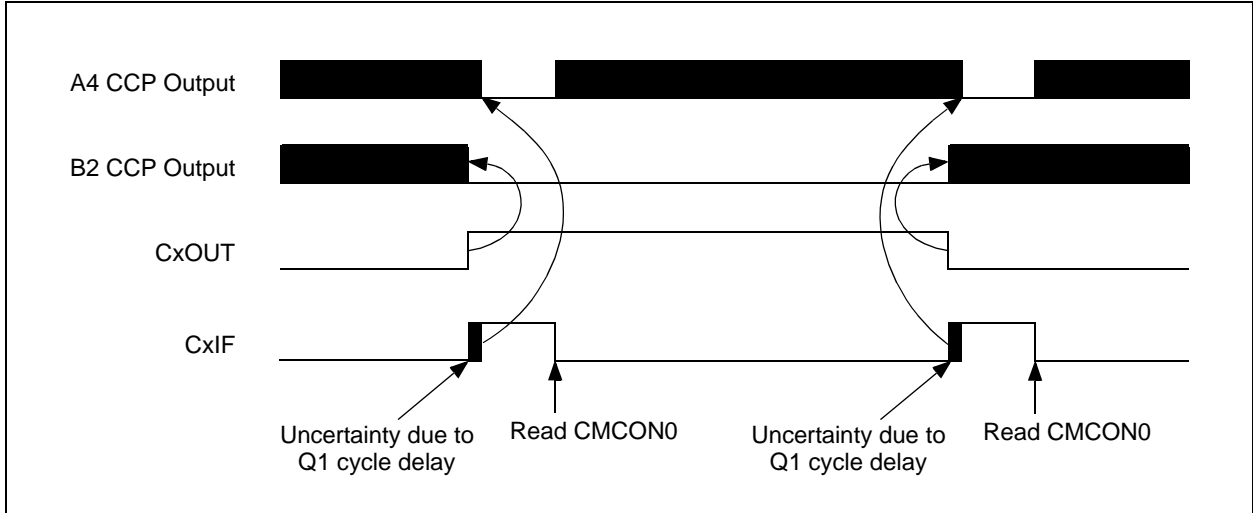
**FIGURE 1: SILICON REVISION A4 VS. REVISION B2**

The Silicon Rev. B2 device (now shipping) has moved the auto-shutdown connection from CxIF to CxOUT. This will eliminate the synchronous shutdown and simplify the use of the comparator for a shutdown event. Figure 1 shows the function of auto-shutdown before and after the device revision.
